**EXCERPTS FROM THE
KODIAK ISLAND BOROUGH
SEISMIC VULNERABILITY ASSESSMENT**

**KODIAK ISLAND BOROUGH SCHOOL DISTRICT
GEOLOGIC AND GEOTECHICAL SEISMIC
VULNERABILITY ASSESSMENT**

Seismic Vulnerability Assessment

*G&E Report 87.01.05, Revision 0
February 12, 2006*

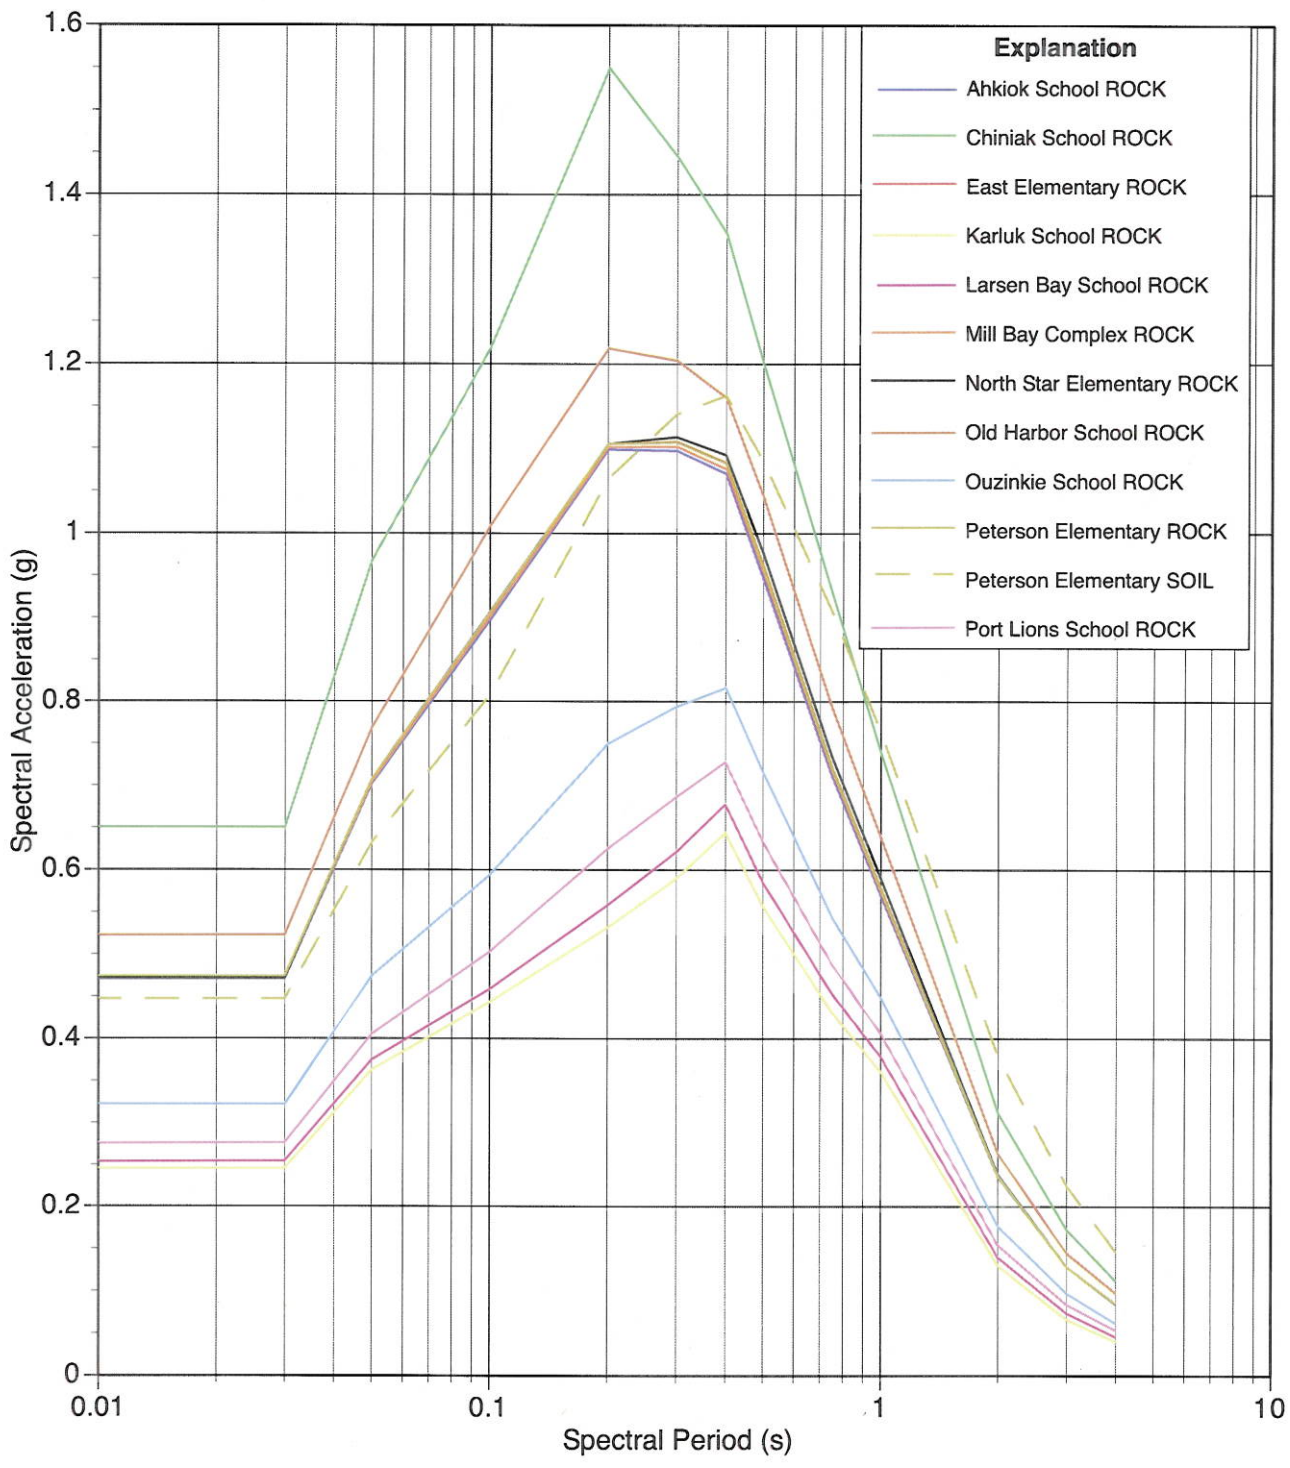
William Lettis & Associates, Inc.
 Figure B-6

**475-Year Uniform Hazard Spectra
for All Kodiak Borough Island School Sites**

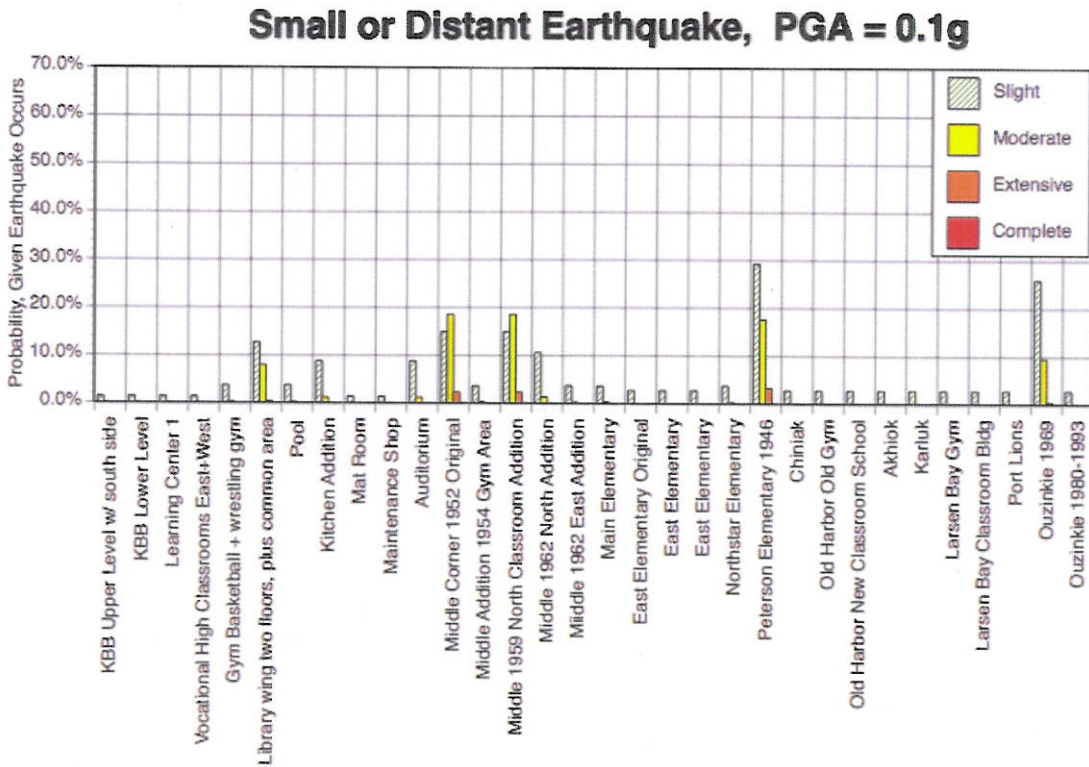
Figure 5-1. Building Performance: PGA = 0.1g Scenario Earthquake

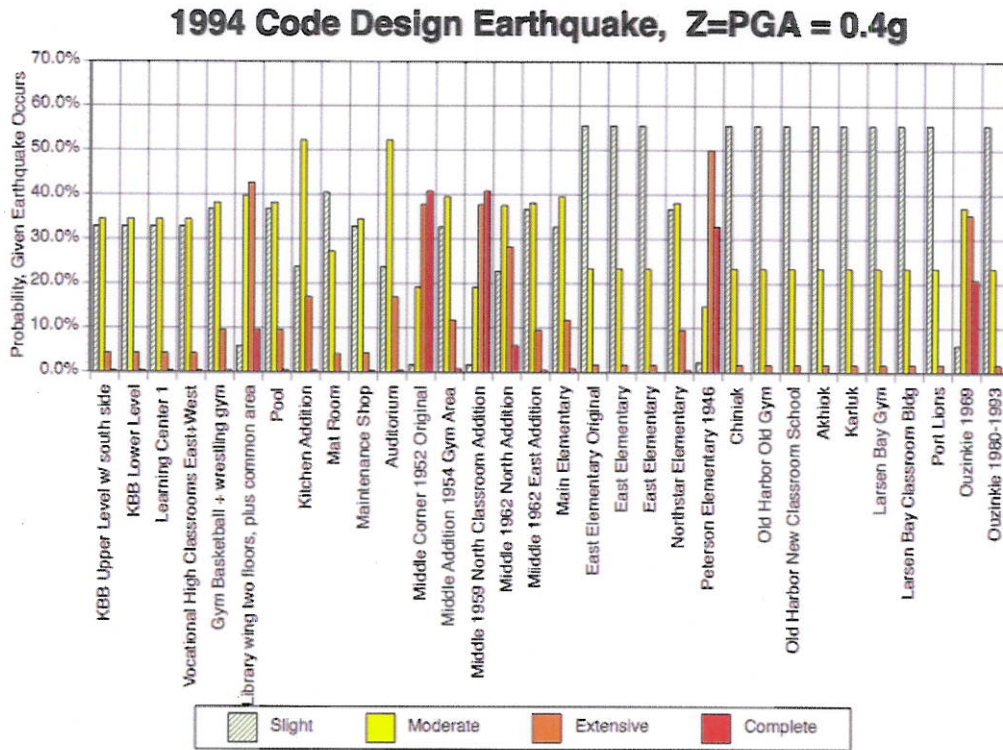
Figure 5-2. Building Performance: PGA = 0.4g Scenario Earthquake

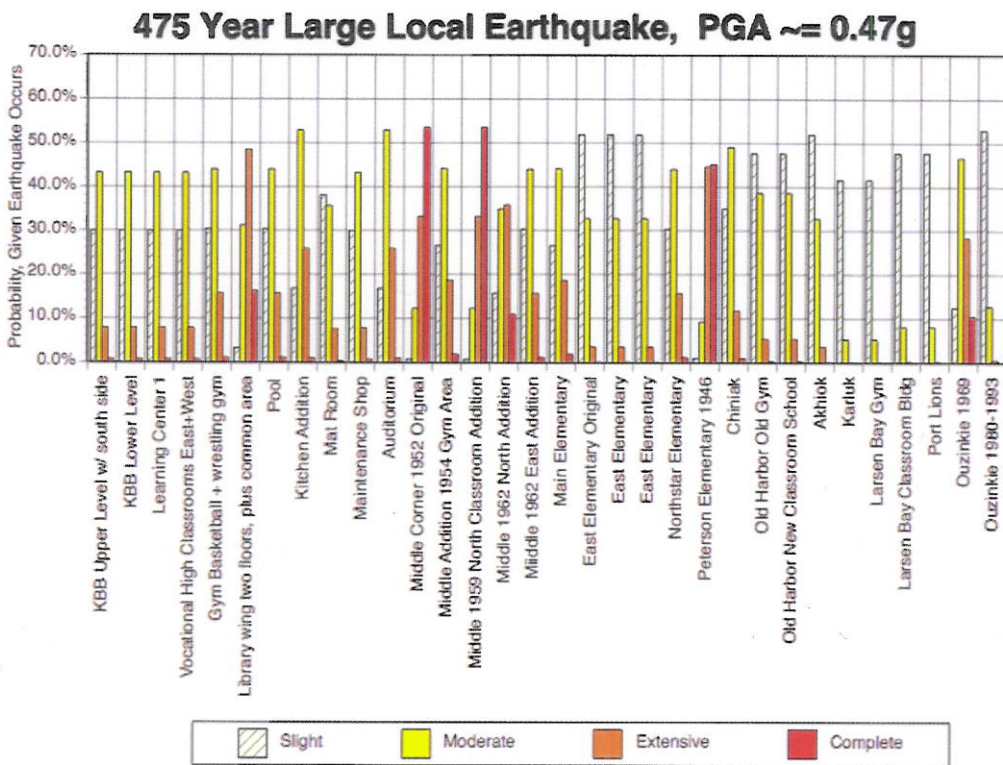
Figure 5-3. Building Performance: 475 Year Scenario Earthquake

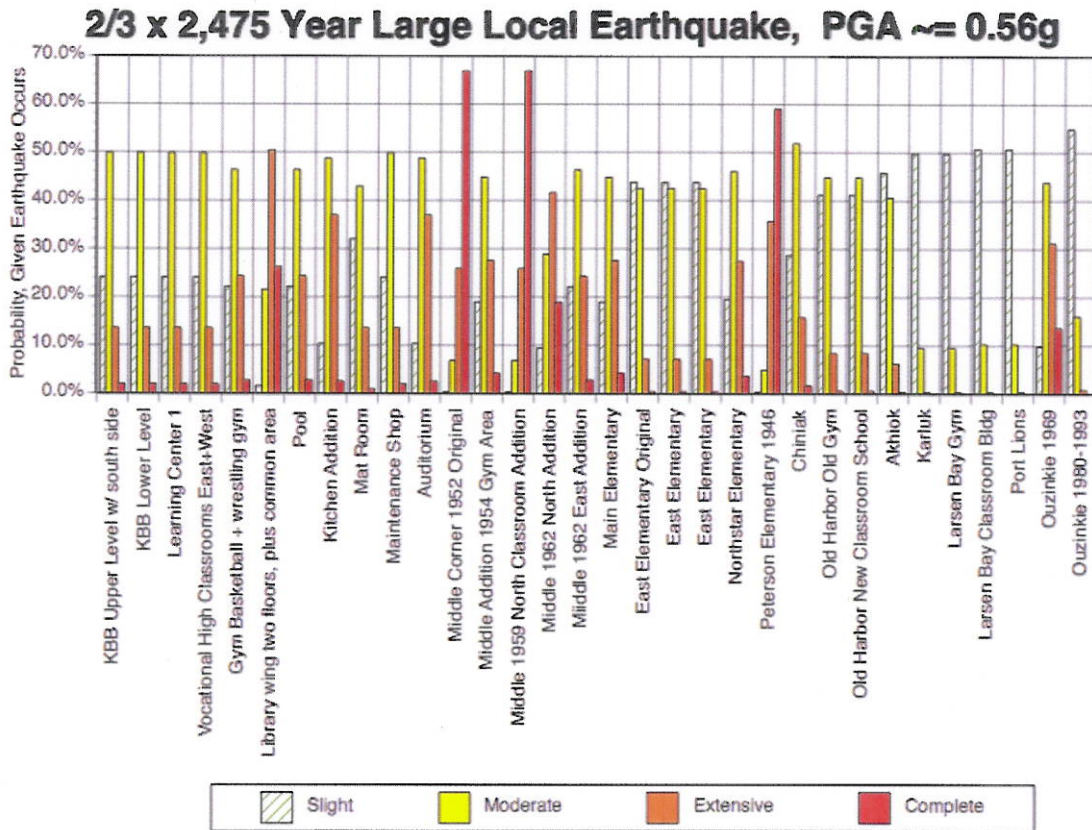
Sections 5.1 through 5.5 describe what is meant by each damage state for the buildings with the greatest chance of significant damage in large earthquakes. For example, Figure 5-4 shows that the High School Library wing has about a 25% chance of being in the complete damage state, given an earthquake that produces PGA = 0.56g at that site. For that same level of earthquake, the nearby Vocational Wing has a 2% chance of being in the complete damage state.

Figure 5-4. Building Performance: 2/3 of 2.475 Year Scenario Earthquake
