City of Seattle

Unreinforced Masonry Building Seismic Hazards Study

December 2007

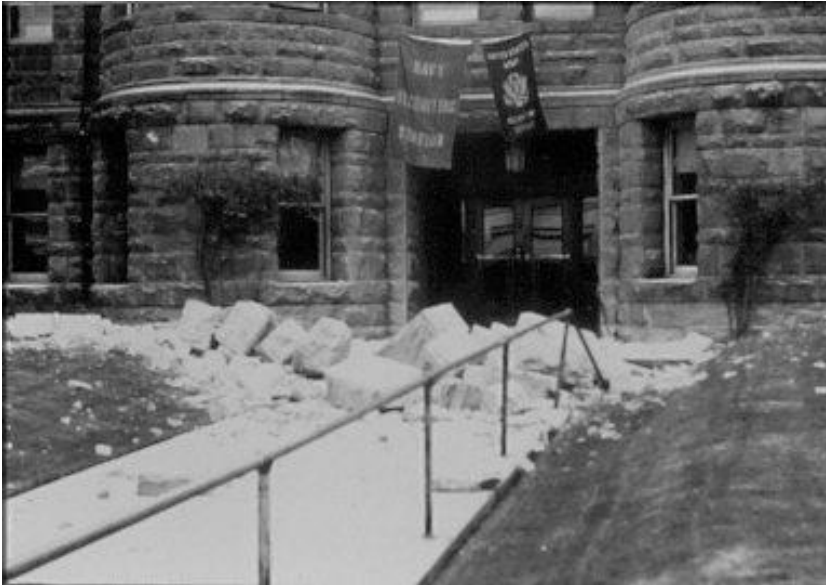
Location 1c. Damage to “old state capitol bulding” in the April 13, 1949 earthquake. Photo supplied by Jim Sims.

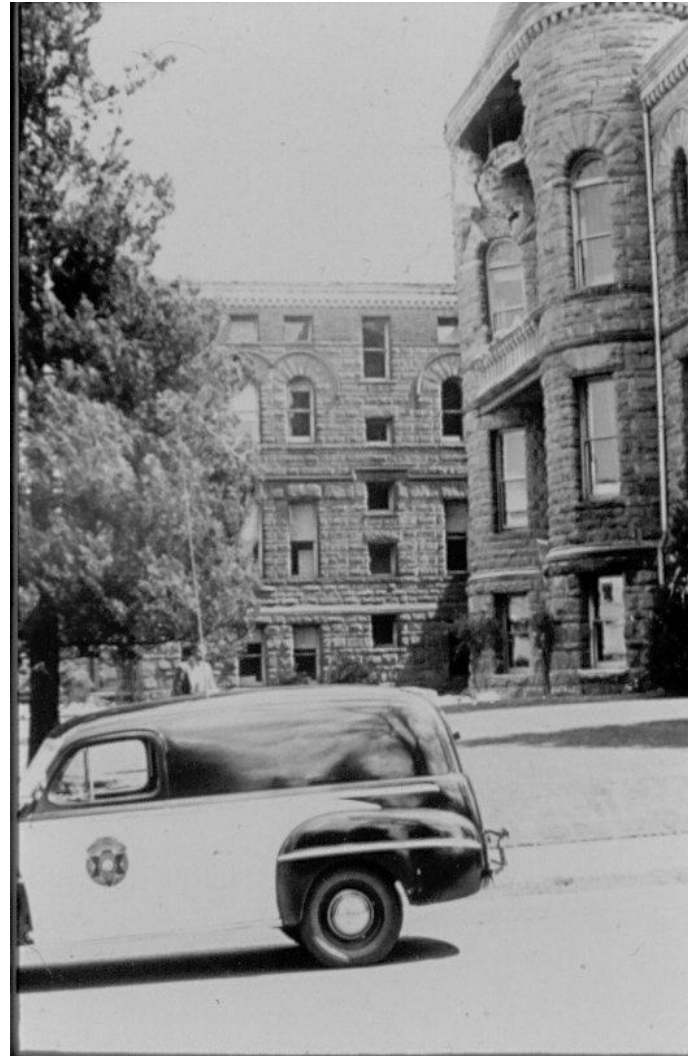
Location 1d. Damage to “old state capitol bulding” in the April 13, 1949 earthquake. Photo supplied by Jim Sims.

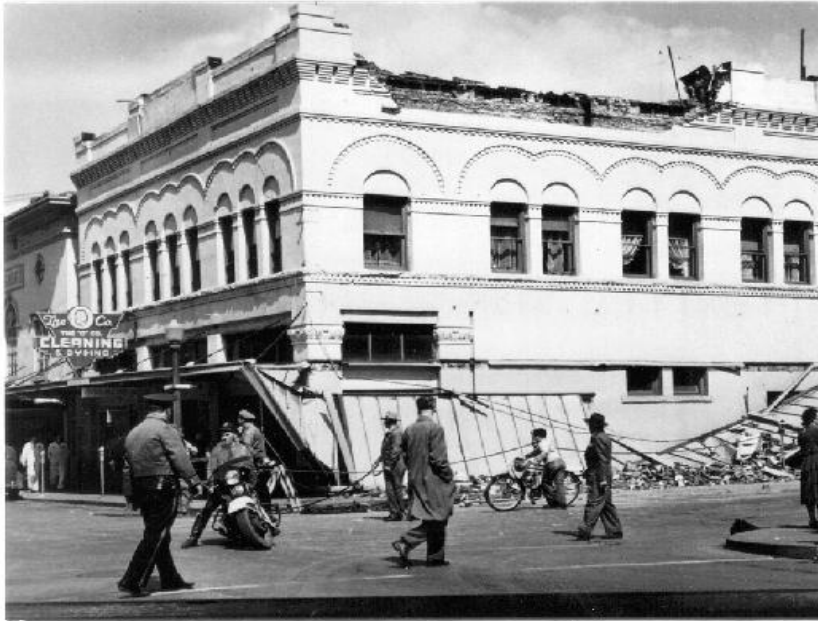
Location 2. Parapet failure in 1949 earthquake, collapsing awning. Although the earthquake occurred at midday on a sunny Wednesday, no one was injured here. Photo by Roger Easton.

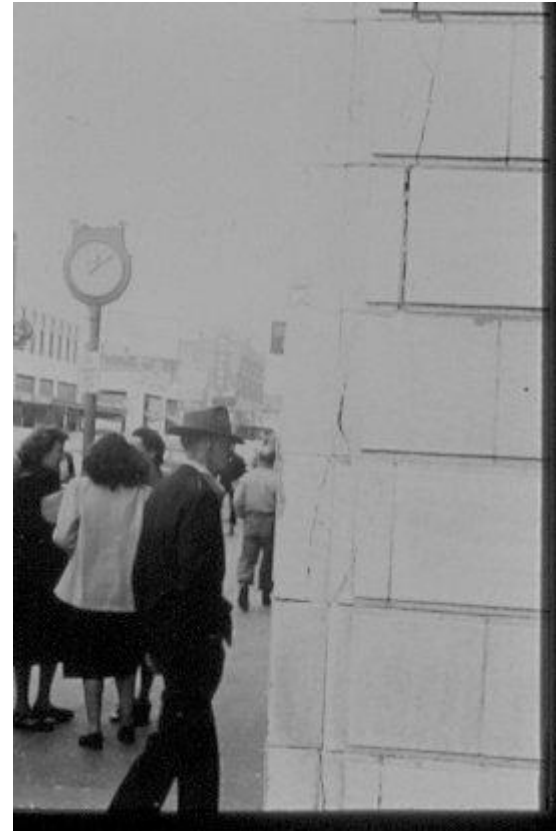
Location 3. Cracking in the wall of the old Capitol Theatre. Photo supplied by Jim Sims.

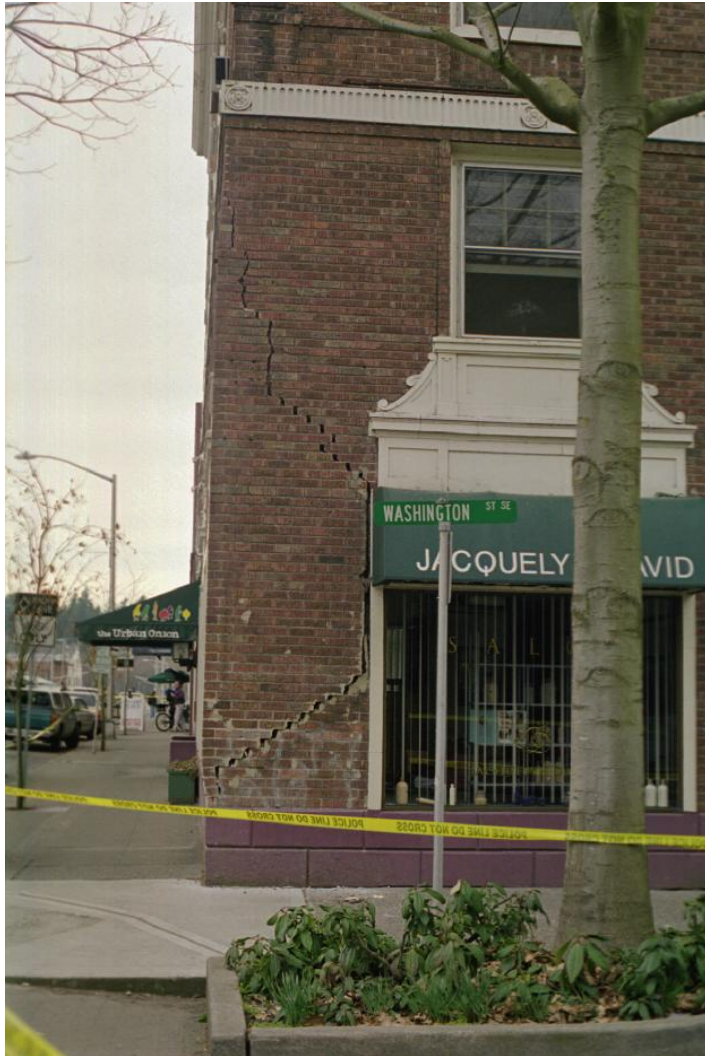
Location 4a. Masonry damage to the Hotel Olympian building in the 2001 Nisqually earthquake. Photo by Josh Logan.

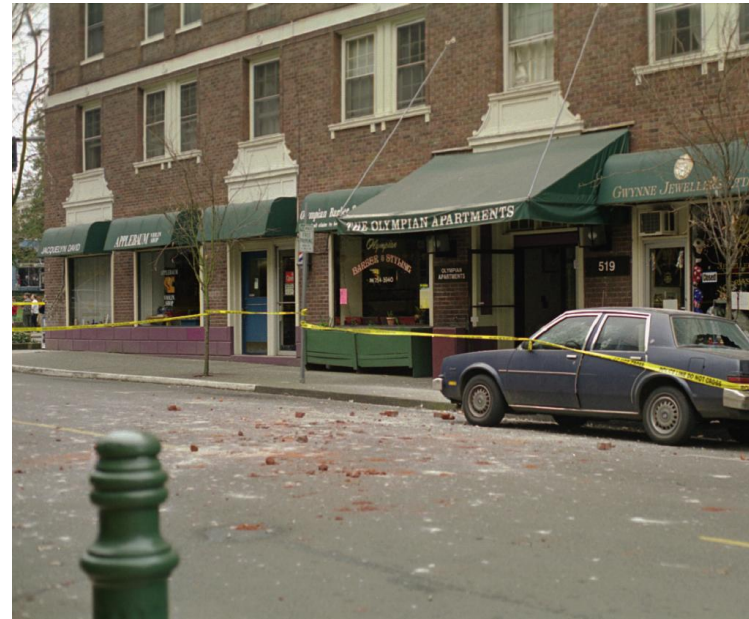
Location 4b. Masonry damage to the Hotel Olympian building in the 2001 Nisqually earthquake. Photo by Josh Logan.

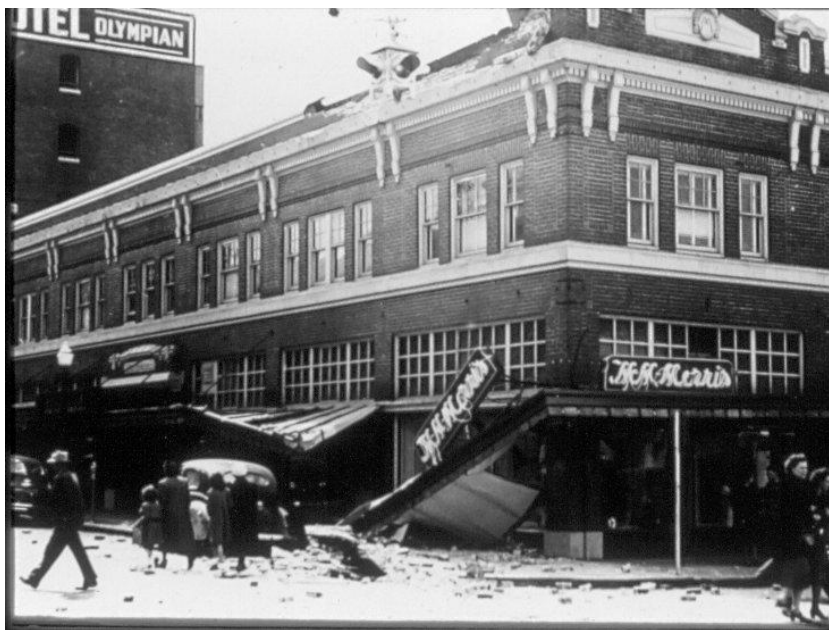
Location 5a. Parapet and awning failure at M. M. Morris, now occupied by Wind Up Here. Photo supplied by Jim Sims.

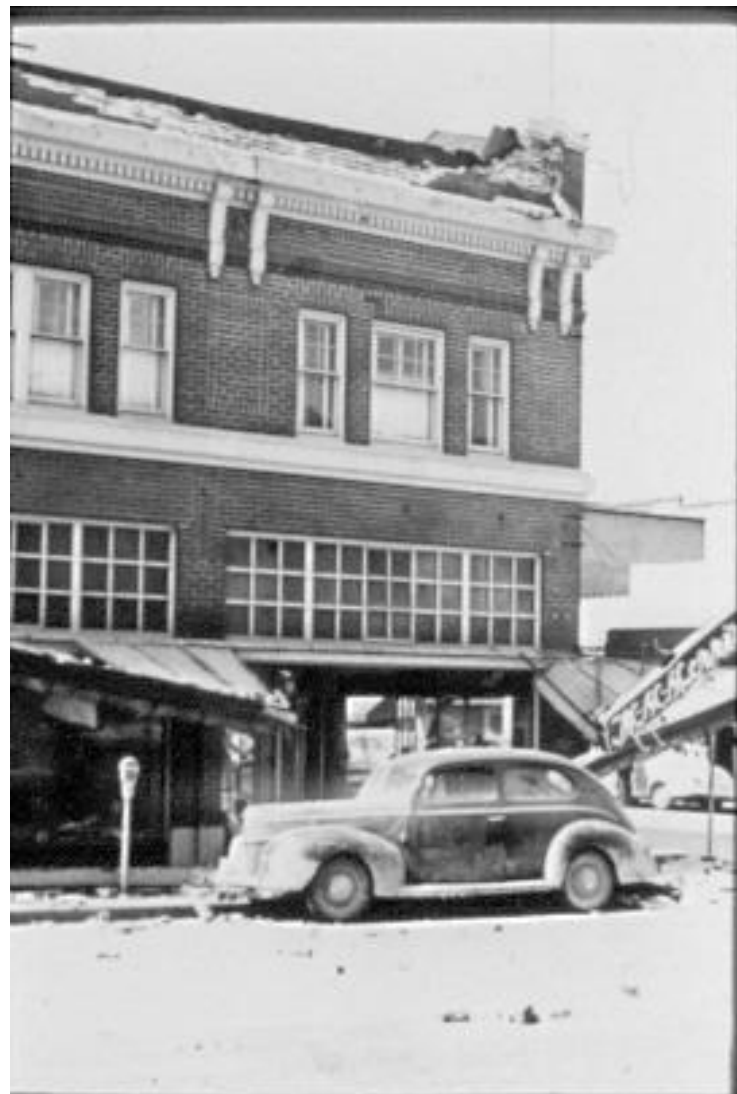
Location 5b Closeup of 5a. Photo supplied by Jim Sims

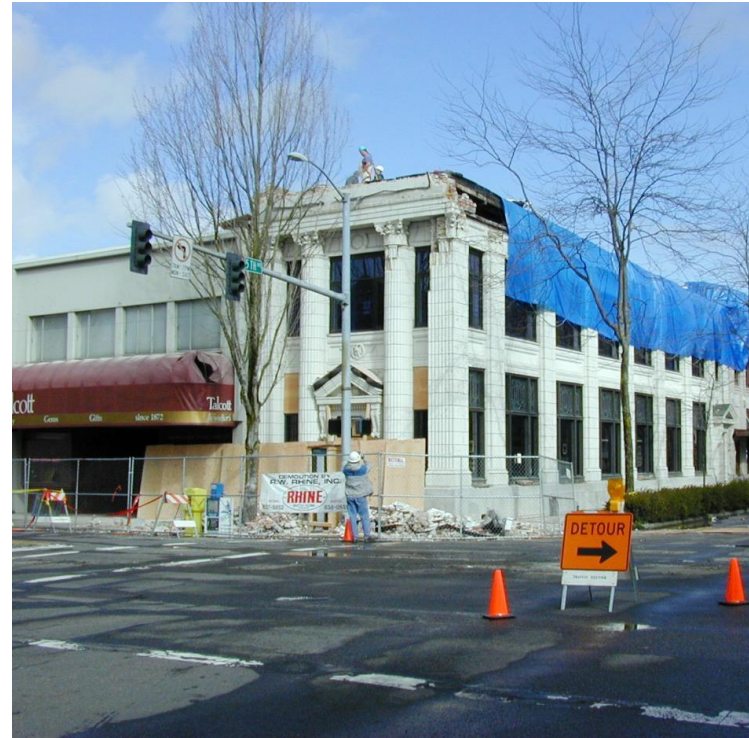
Location 7a. Damage to the Washington Federal Savings building. (now occupied by Reflections Gallery. Photo by Josh Logan.

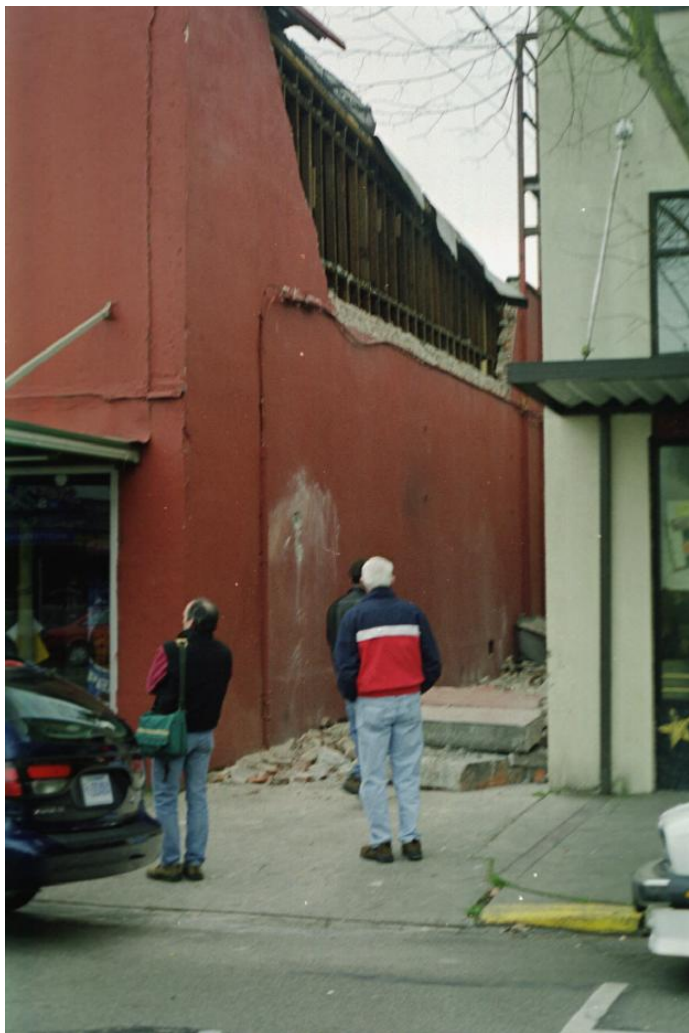
Location 8a. Damage to Skookum Bay outfitters, now Batdorf and Bronson Coffee Roasters and, until recently, Cielo Blu. This extensive damage bankrupted the business. Photo by Josh Logan.

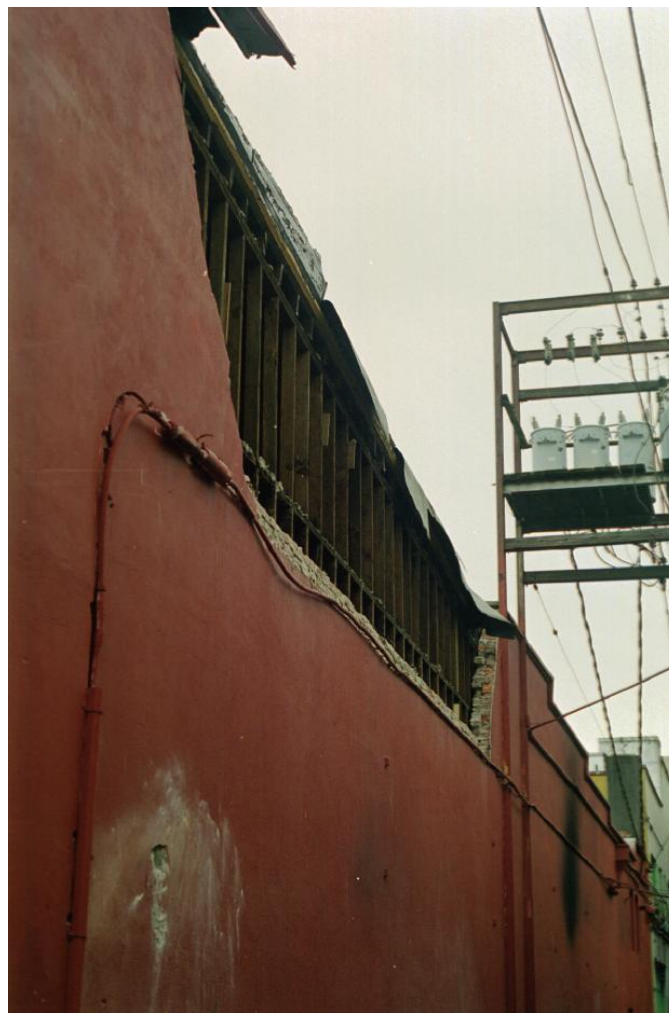
Location 8b. Closeup of 8a. Skookum BayOutfitters owned this building but did not have earthquake insurance and was unable to get an SBA loan. Photo by Josh Logan.
