5.6 Other Cities in High Seismic Areas

Cascadia Region Earthquake Workgroup
Sharing Information to Promote Mitigation

Deep earthquakes

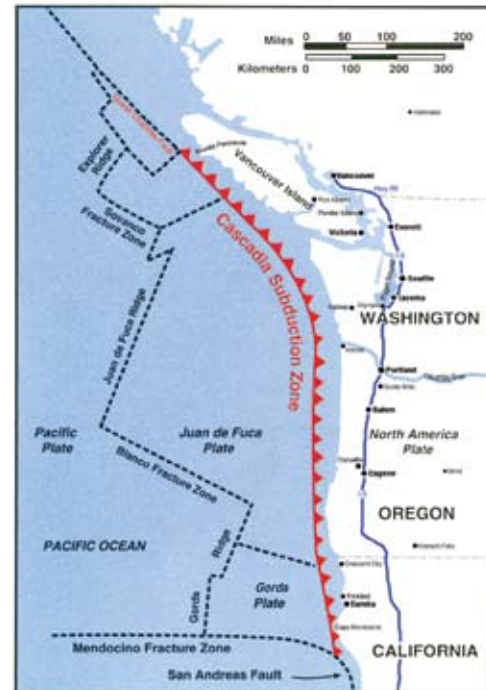
The Cascadia subduction zone stretches 800 miles (1,300 km) from the Brooks Peninsula, Vancouver Island to Cape Mendocino, California. As the Juan de Fuca and Gorda plates descend beneath the North America plate (red hatched line), active geologic processes affect the entire overlying region. Map: Oregon Department of Geology and Mineral Industries (DOGAMI)

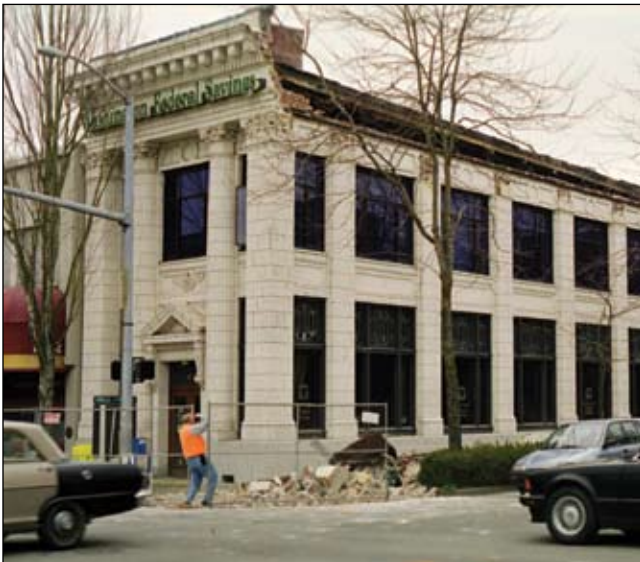
This photo of a building in Olympia after the 2001 Nisqually earthquake shows typical damage from a deep earthquake. A major source of injury is falling parapets, such as those seen above. Photo: Josh (Robert) Logan, DGER

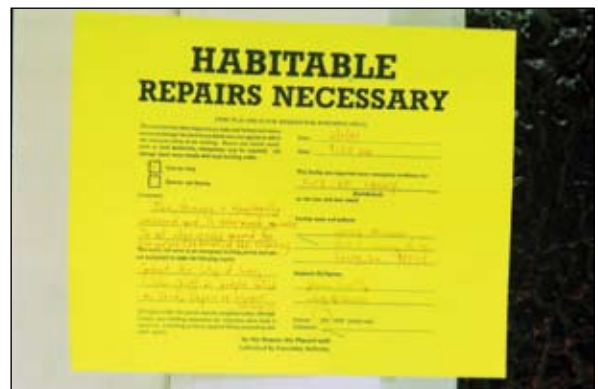
Many structures, utility lines, and transportation systems (road, air, rail, port) need to be inspected after a large earthquake. Structures can be given a yellow tag, like this one, meaning it can be used to some extent but repairs must be made. A red tag means the structure cannot be used until it is repaired. Photo: William S. Lingley, DGER

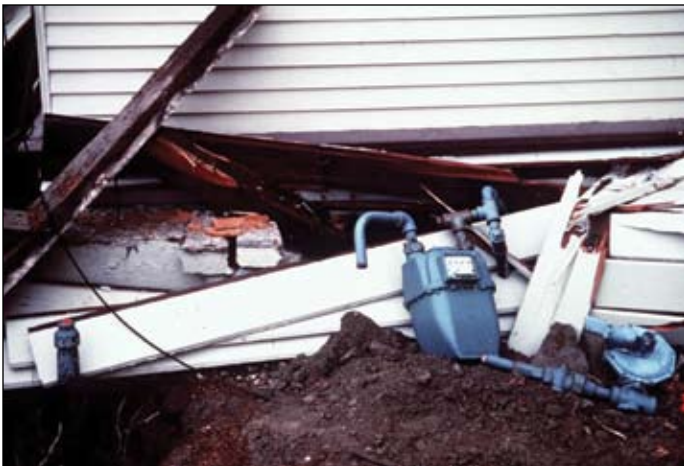
This house shifted off its foundation, breaking the utility lines and leaving it uninhabitable. Newer building codes require a house being tied to the foundation, but homeowners may need to retrofit older homes. Photo: USGS

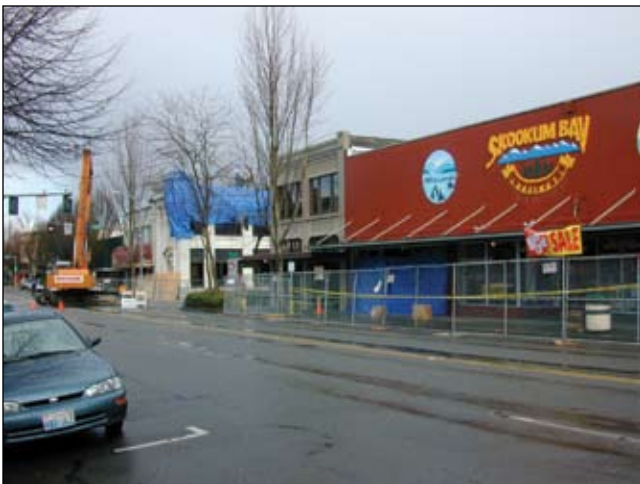
Closed businesses and disrupted streets, like this one after the Nisqually earthquake, can be a problem for the economic health of communities. Photo: Robert J. Reid

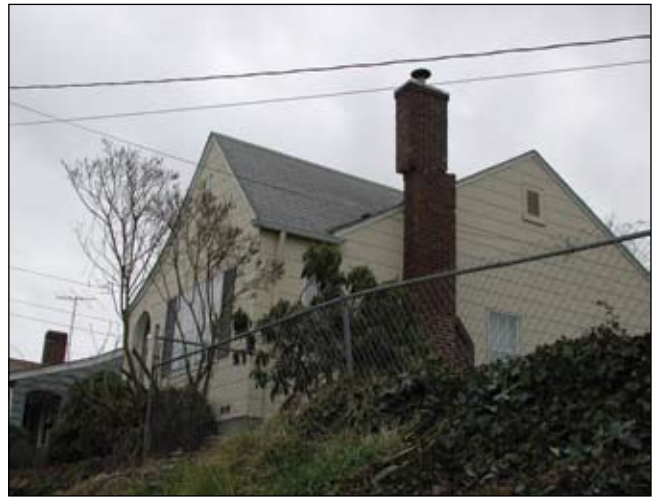
Chimney failures are a common problem for homeowners after an earthquake. The above chimney did not fall but remained a safety hazard until it was rebuilt. Photo: Michael Polenz, DGER

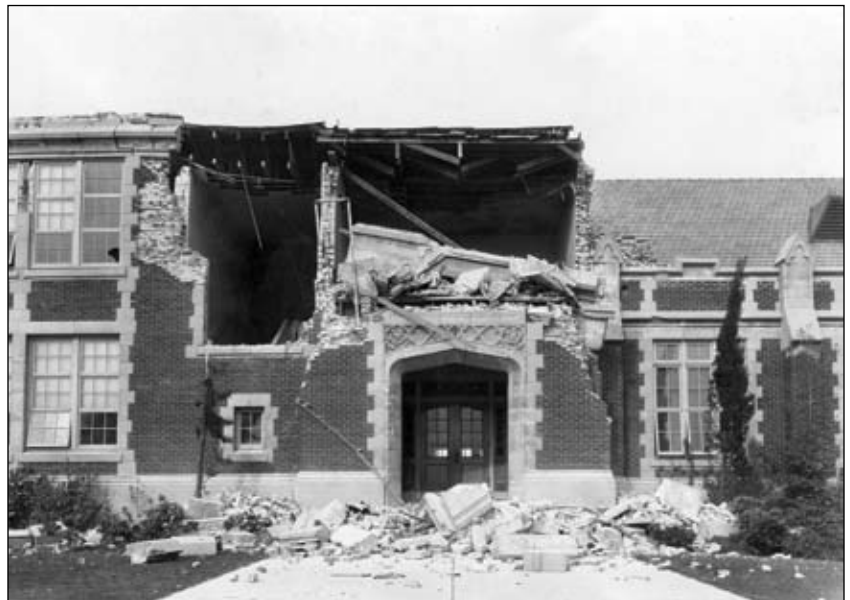
The Long Beach, California school above shows how dangerous old, brick buildings can be. In the 1949 Olympia earthquake, the Senior Class President of Castle Rock High School was killed by falling bricks. The gable on the school collapsed, even though the structure was more than 50 miles (80 kilometers) from the epicenter. Photo: USGS

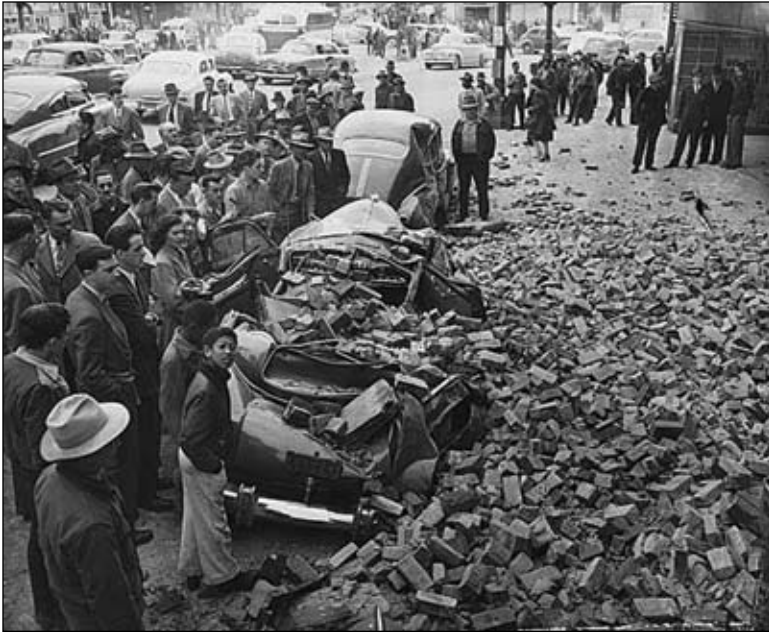
During the April 1949 earthquake, the owner of the Busy Bee Cafe barred the doors to keep panicking patrons from rushing outside. Seconds later, brick fell from the top of the Hotel Seattle, crushing several cars. Photo: Seattle Post-Intelligencer Collection, Museum of History & Industry; All Rights Reserved

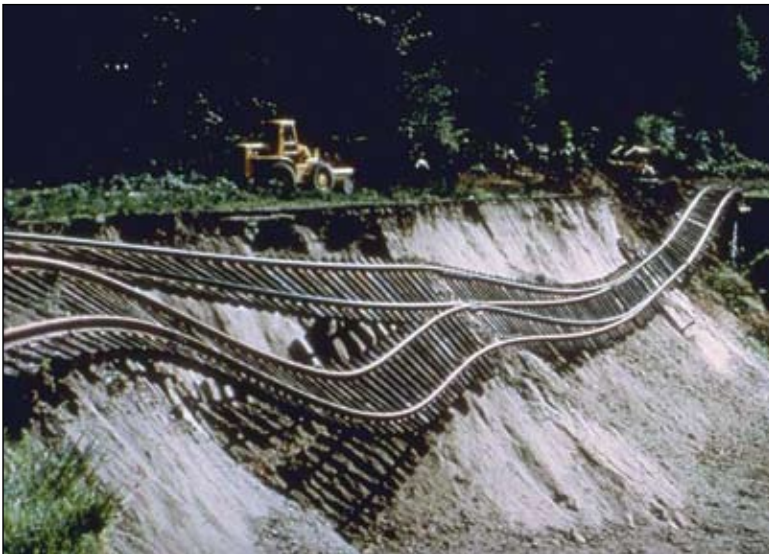
Landslides are an often-overlooked danger of earthquakes. They are particularly likely during rainy, water-soaked winter months in Cascadia. Almost 40 miles (60 kilometers) from the epicenter, this section of the Union Pacific Railway was left dangling after the hillside fill beneath it slid away in the 1965 earthquake. A sewer main also broke. Photo: University of California, Berkeley

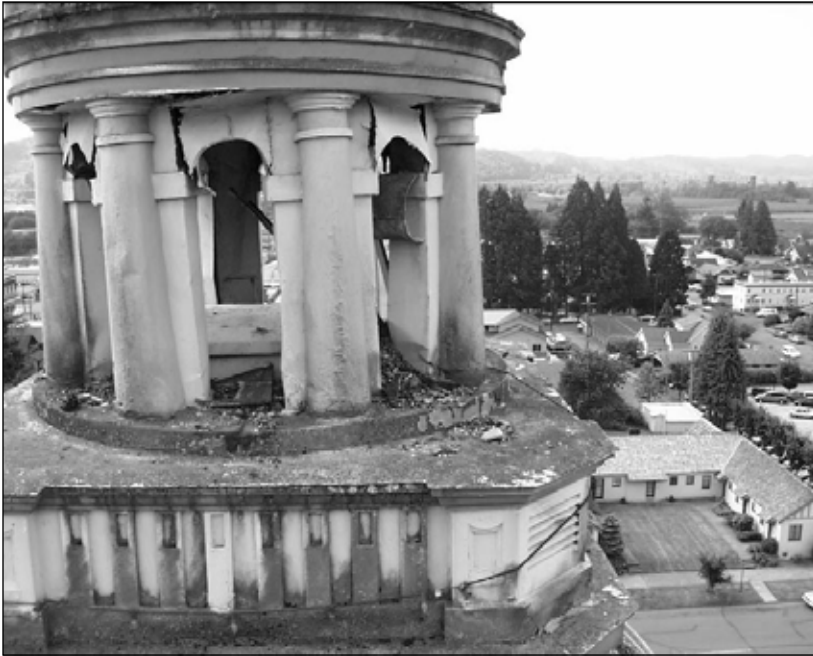
The historic Grays Harbor County Courthouse in Montesano, Washington suffered several million dollars' worth of damage in the 1999 earthquake. Photo: Grays Harbor County

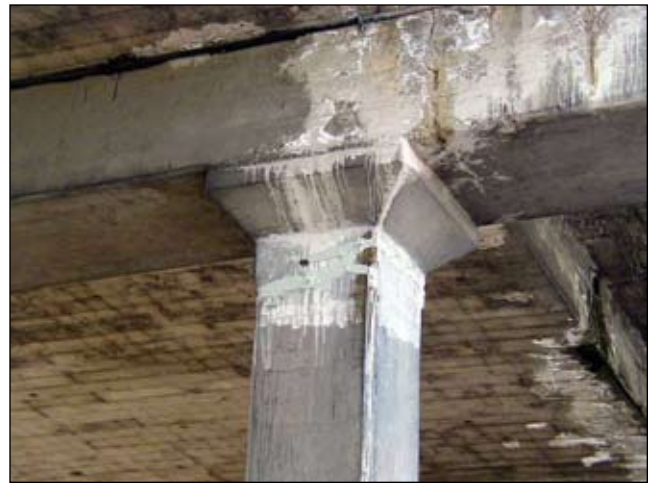
The South Park Bridge in Seattle suffered extensive damage. Above is one of 22 columns that cracked in the earthquake. Epoxy was injected to shore up the structure. Crews worked round the clock to repair this and other structures throughout the area. Photo: King County

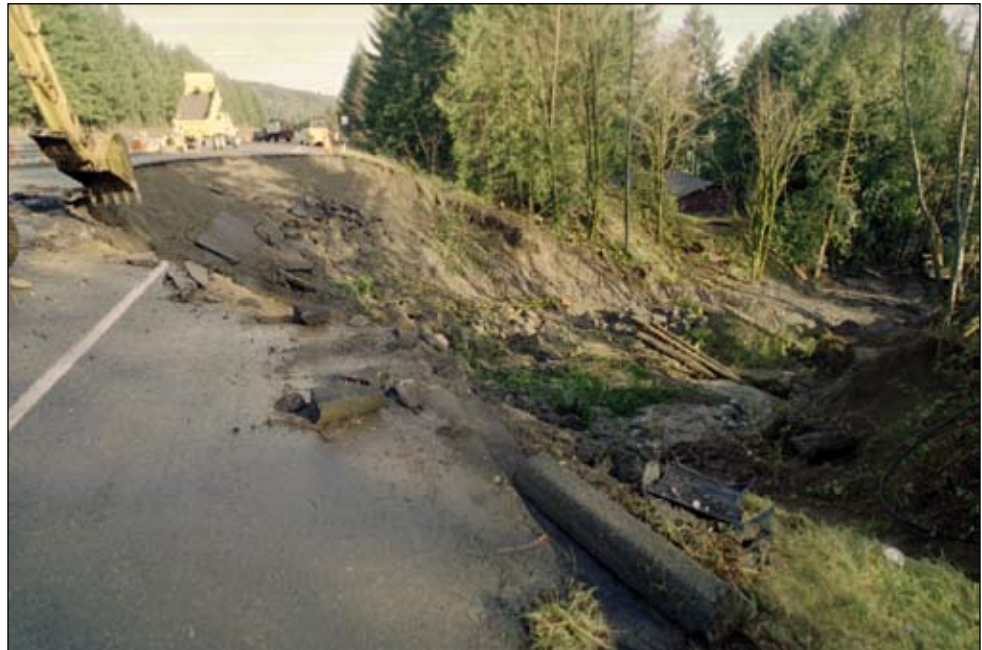
Liquefaction, lateral spreading, and landslides damaged many roads throughout the area. Photo: William S. Lingley, DGER

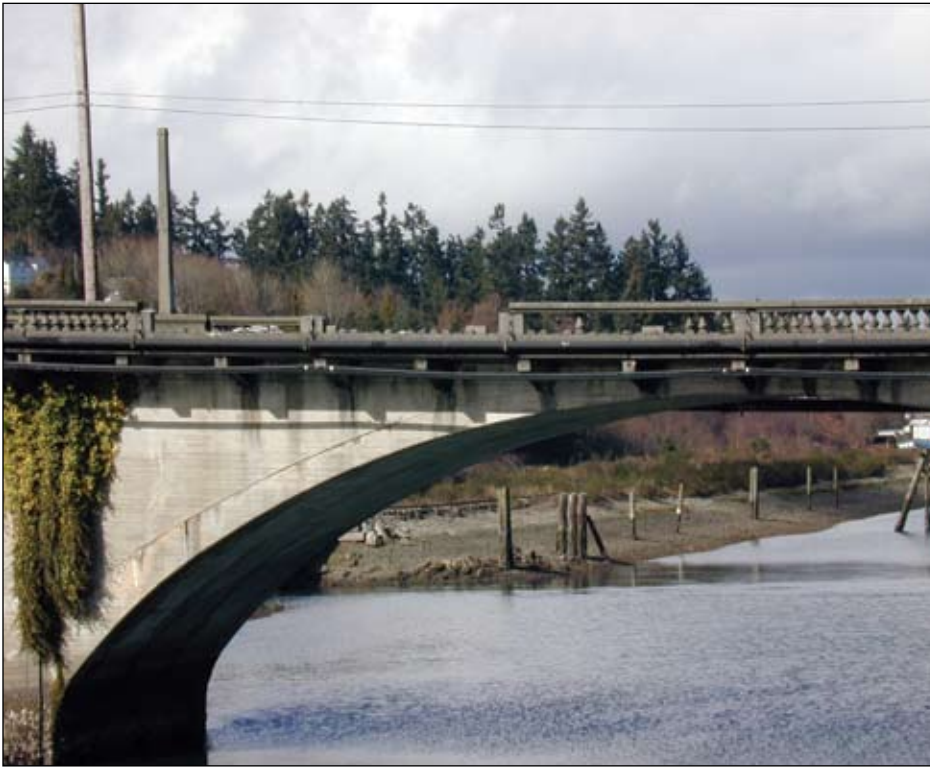
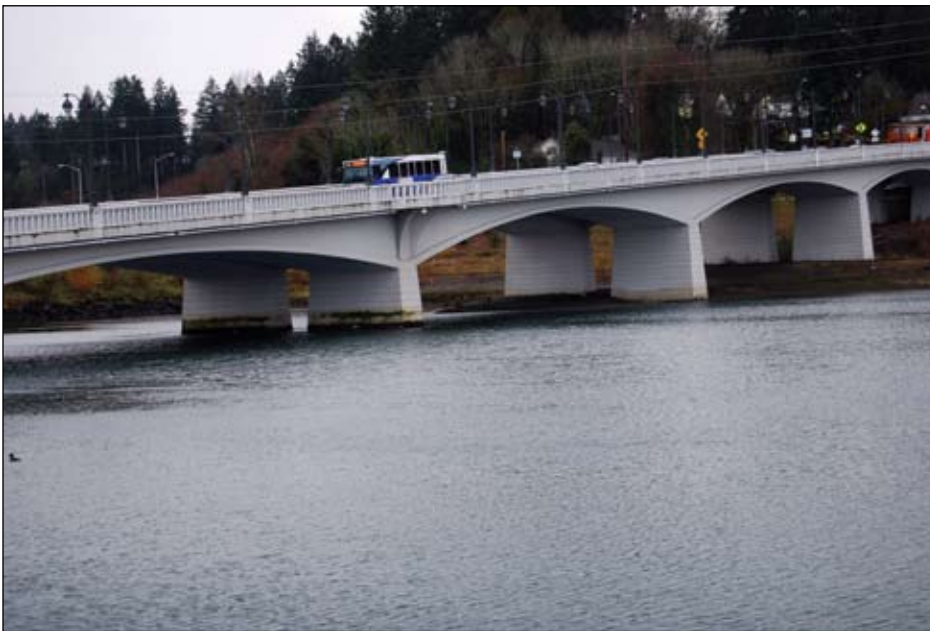
Olympia's Fourth Avenue Bridge was closed after the earthquake because of severe damage (above). The rebuilt structure (below) is an asset to the community, not only because of its aesthetics, but because it was designed for pedestrians and bicyclists as well as automobiles. Above photo: Robert J. Reid; Below photo: Timothy J. Walsh, DGER

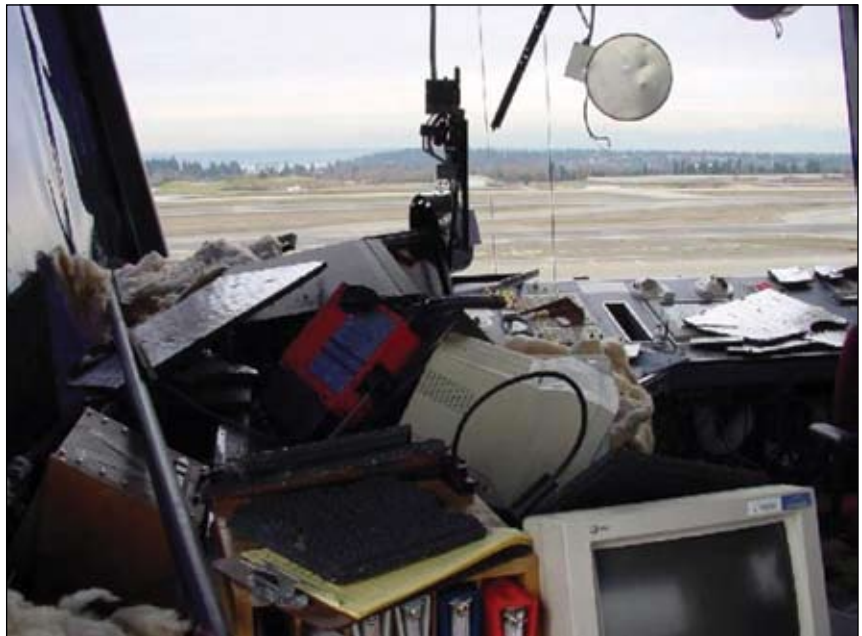
The tower at Sea-Tac sustained both structural and nonstructural damage. Even so, the airport was able to reopen after a few hours. Photo: Washington State Department of Transportation

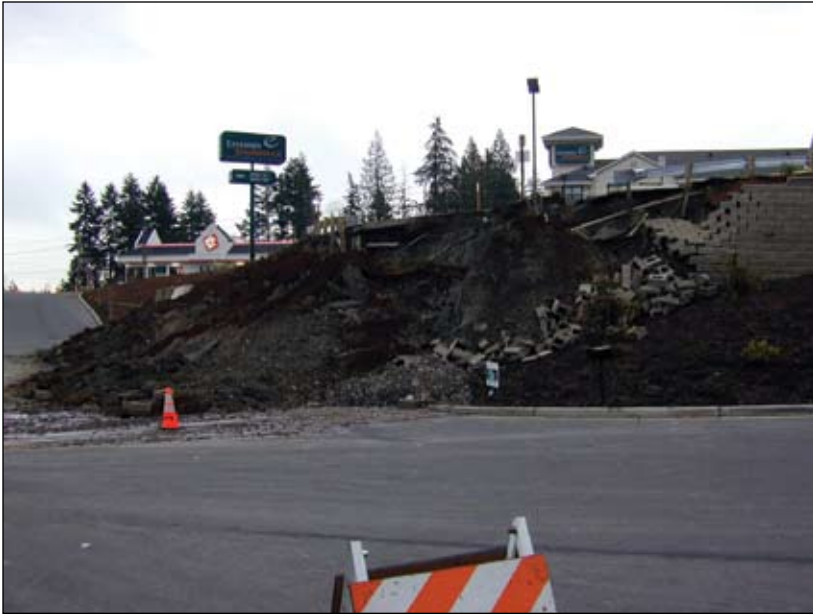
Liquefaction and landslides can break utility lines as well as damage roads and property. With widespread damage, repairs may take longer than expected. Photo: Robert J. Reid

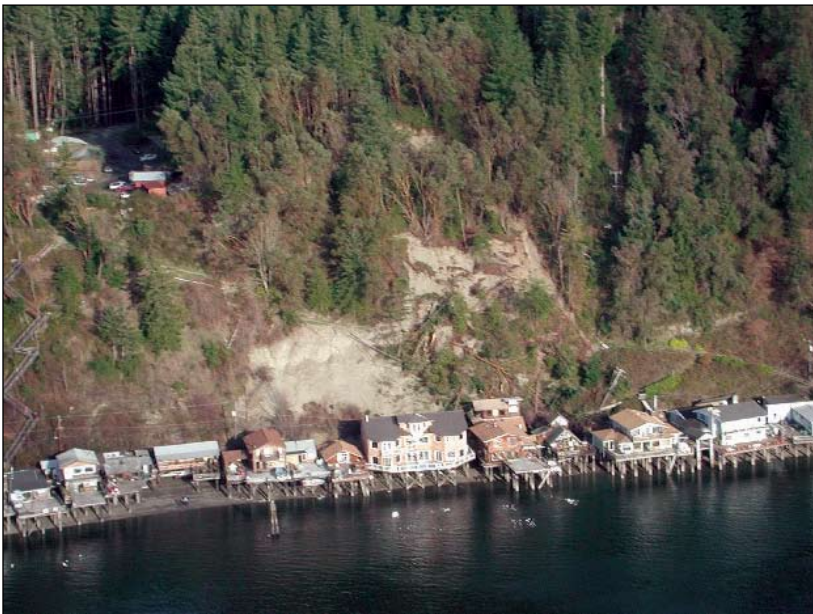
Salmon Beach, near Tacoma, was the site of a landslide three days after the 2001 earthquake. The same hillside slid after the 1949 event. Photo: Dave Sherrod, USGS

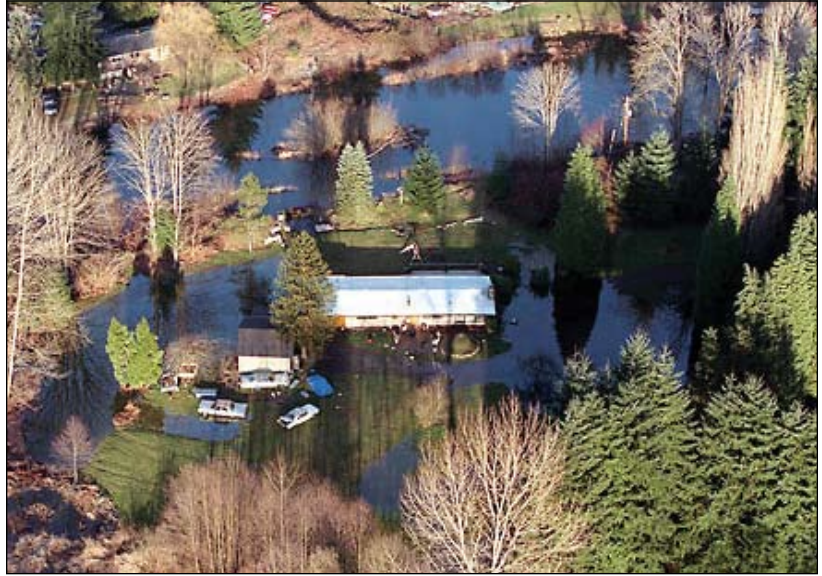
A landslide dammed the Cedar River, resulting in flooding that damaged two houses. Photo: King County

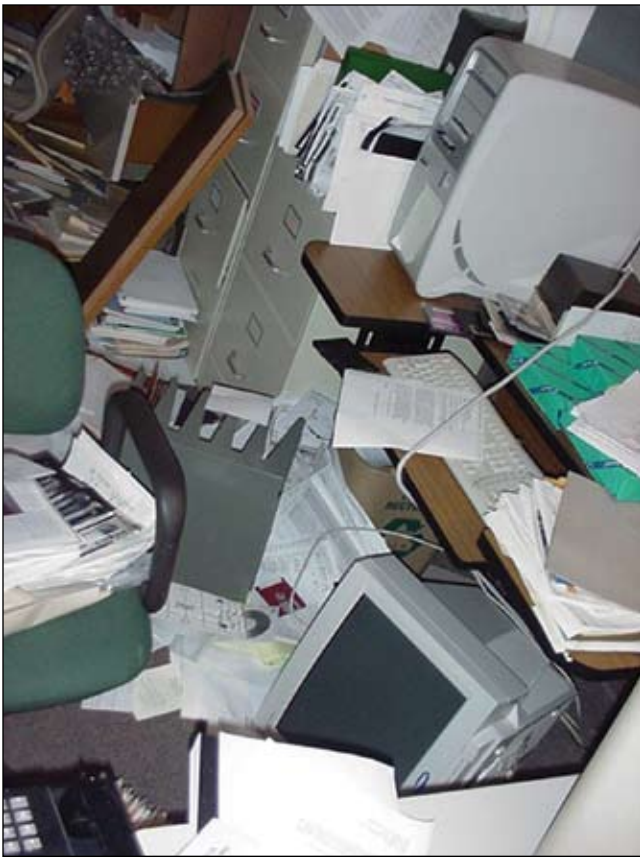
Nonstructural damage in homes and offices, like bookcases, computers, and dishes falling, can be dangerous and expensive. Photo: Ray Lasmanis, DGER

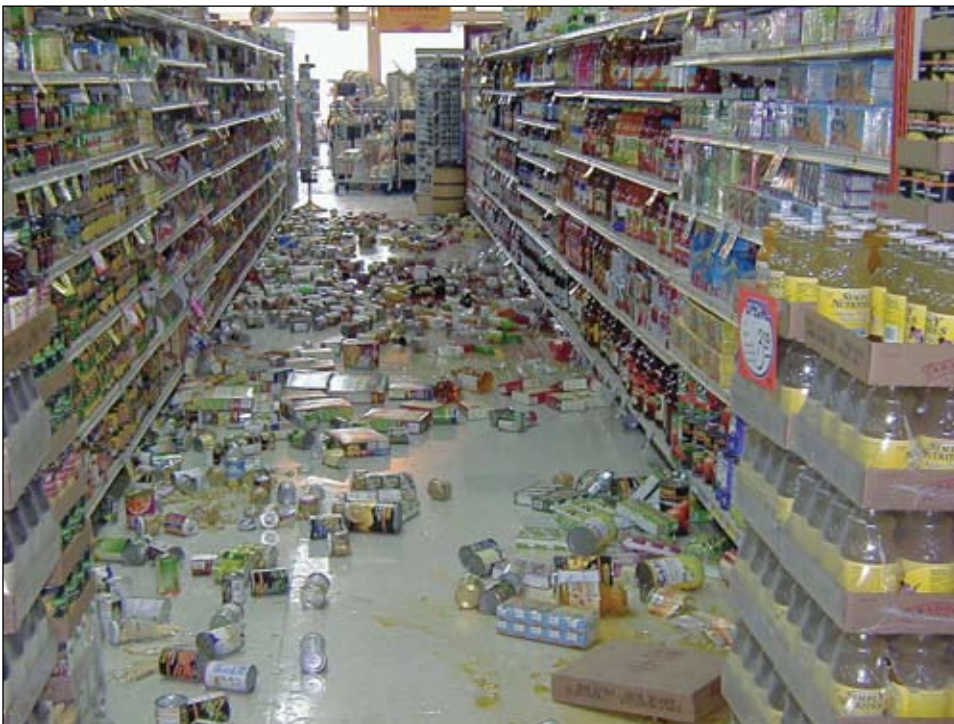
Merchandise spilled off shelves in the Nisqually earthquake. It creates a safety problem for business employees and customers, and also diminishes the amount of resources available for use after the earthquake. Grocery stores, among others, have the type of stock needed to respond to, and resupply after, an earthquake. Photo: Brian Sandwick

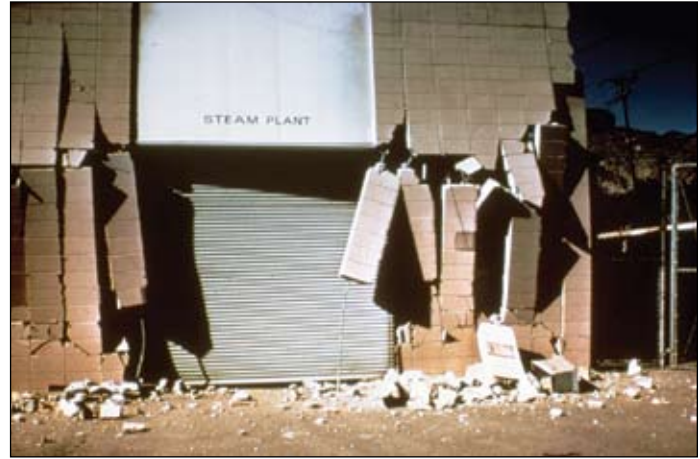
The 1971 San Fernando earthquake substantially damaged these Juvenile Hall facilities. A portion of the two-story administration building collapsed completely into the first story. Photo: E.V. Leyendecker, USGS

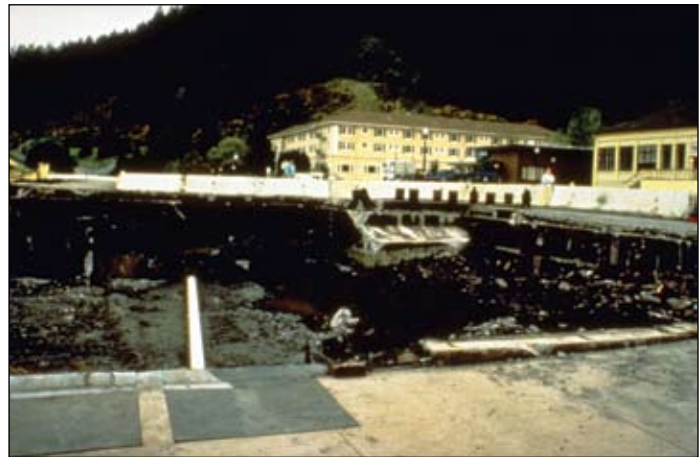
The mall in Scotia, California was destroyed by a fire after an earthquake. Before the fire, the mall consisted of a lumber yard, pharmacy, coffee shop, grocery store, and variety store. Long-term recovery planning gives communities a framework for post-disaster rebuilding. Photo: Lindie Brewer, USGS
