SCHOOL HAZARD IDENTIFICATION & RISK MANAGEMENT IN ALASKA

Laura W Kelly, PE

Alaska's Next Big Earthquake and Tsunami:
Mitigating Impacts Workshop
Anchorage, AK - May 09, 2017

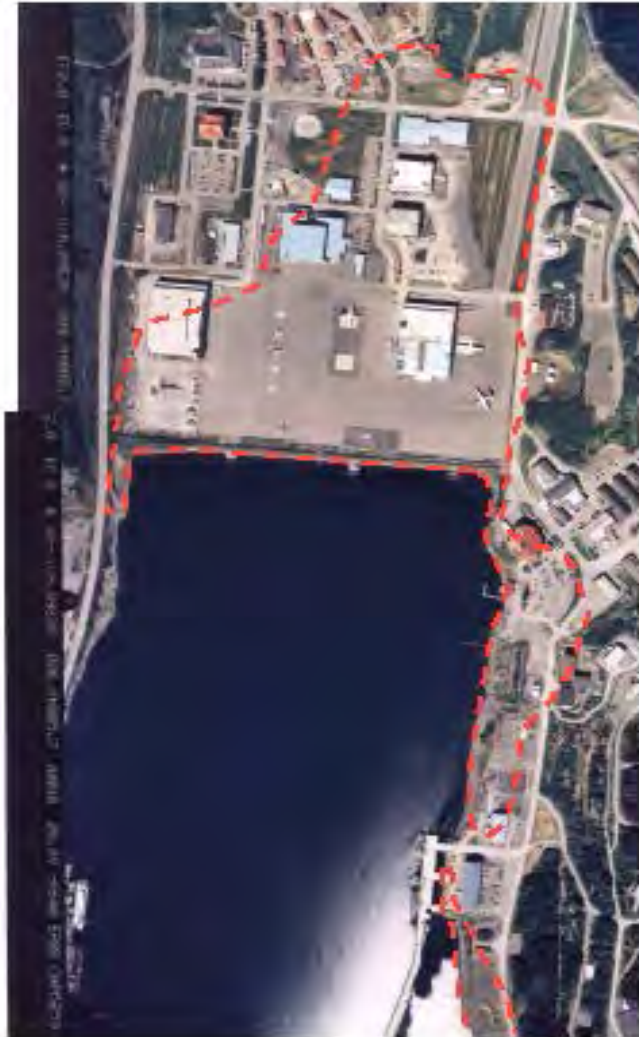
Figure 7. Hydraulic fill (dashed red lines) at the upper end of Womens Bay.

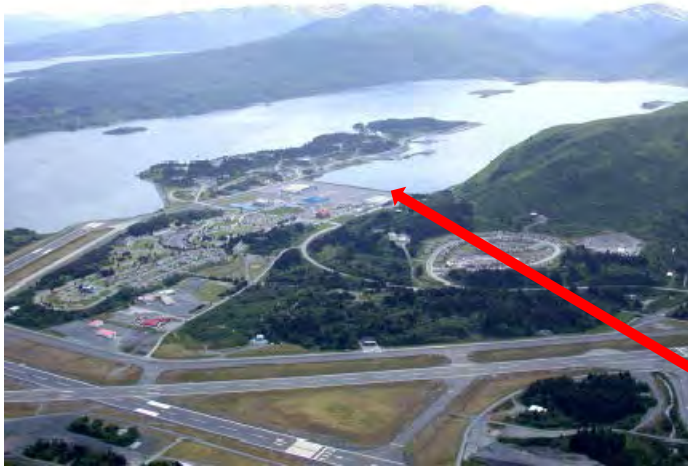
Hydraulic Fill Area, USCG Base Kodiak

(Hazard analysis reveals that recent seismic retrofits did not take liquefiable soils into consideration)

Figure 7. Hydraulic fill (dashed red lines) at the upper end of Womens Bay.

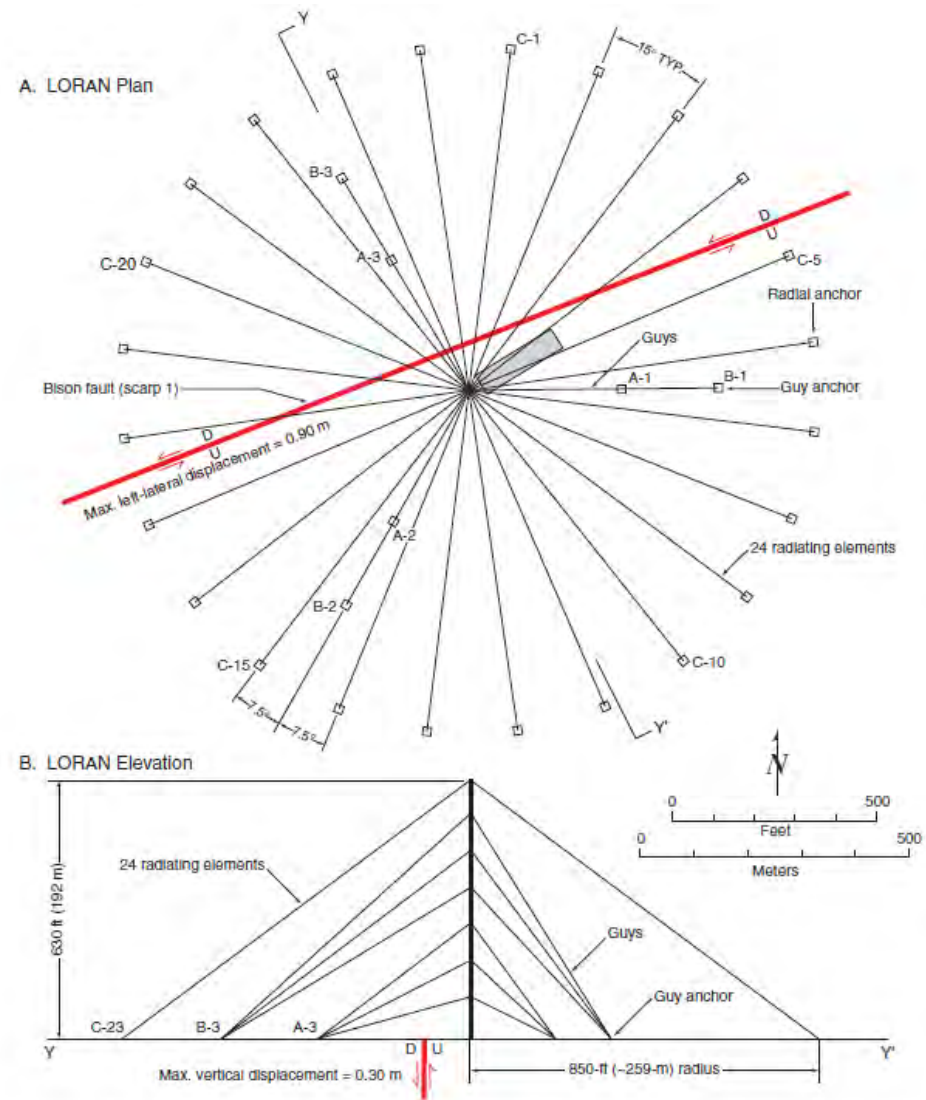
Figure 14. Plan and elevation designs for Kodiak LORAN guy and radial array and anchor system showing location of the Bison fault (scarp 1). Based on paleoseismic trenching of scarp 1, the maximum lateral component of slip (A) assuming a lateral-to-vertical slip ratio of 3:1 is 0.90 m. The maximum vertical component of slip (B) expected is 0.30 m (Table 3).

Lettis & Associates later become involved with school hazard identification in Kodiak. Revised ground forces from LORAN project quantified and incorporated into school analysis.

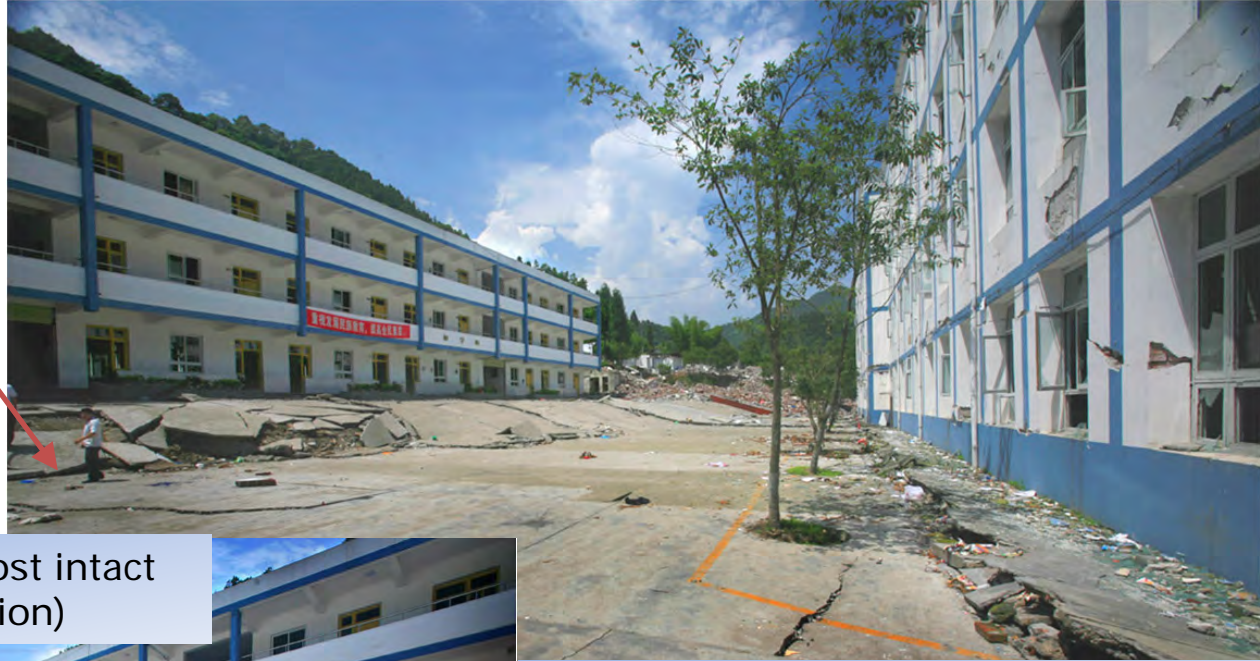
(Note buildings in background collapsed into rubble.)

Diligence Building – almost intact
(5-10 year old construction)

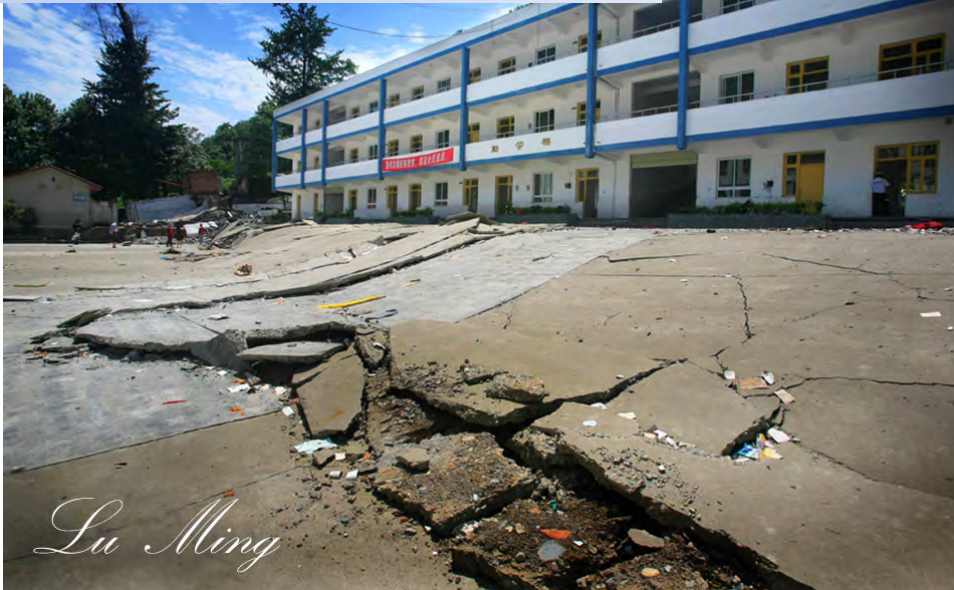
Learning Building – basically intact
(10-15 year old construction)

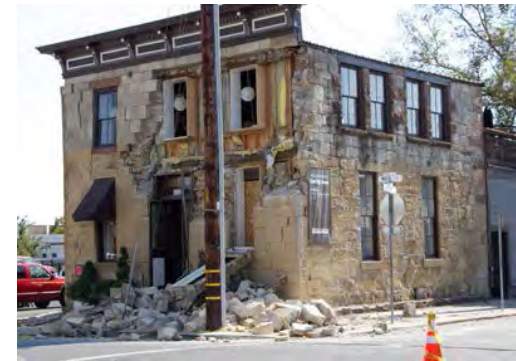
Napa earthquake damage to a building without seismic retrofit

Recent example of a successful school retrofit program was demonstrated during the magnitude 6 earthquake that struck Napa, California in 2014, producing peak ground accelerations of 60% to 100% as strong as the acceleration due to gravity. The earthquake and its aftershocks injured 90 people and caused approximately \$1 billion of damage.
